Narrative Information Sheet

R04-19-C-003

4. Property Information: Former Elks Lodge, 504 Washington Avenue, Greenville 38701

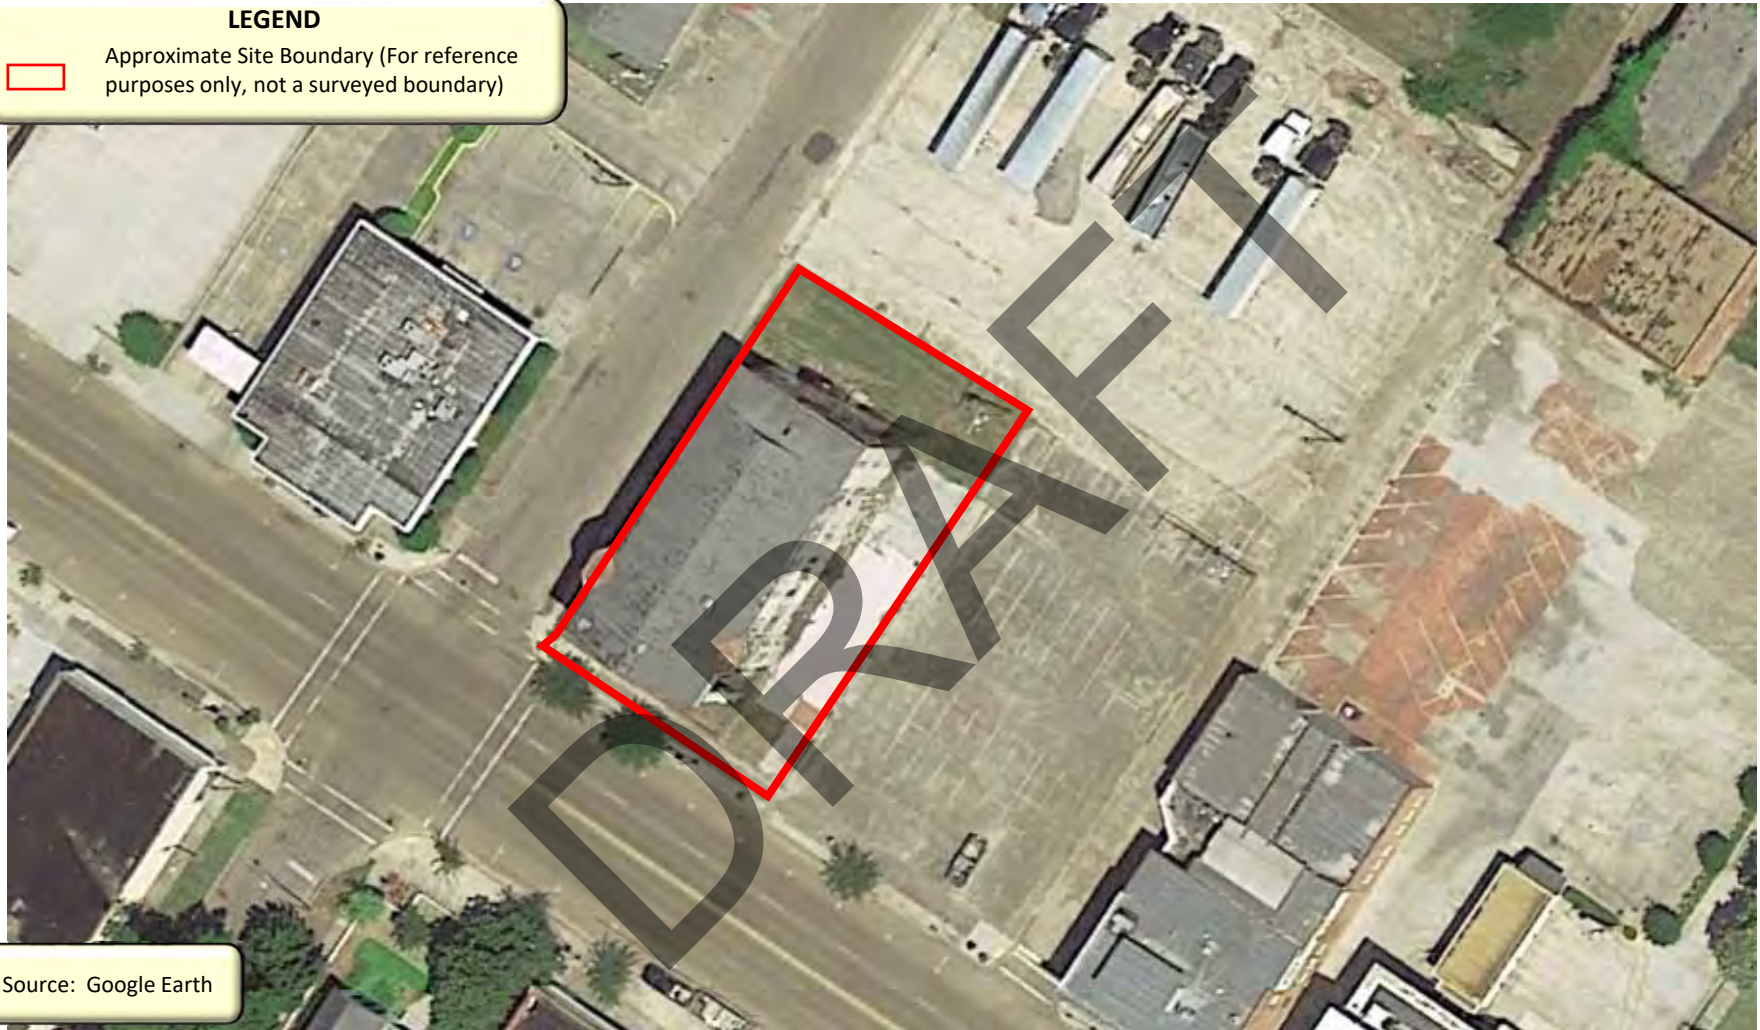
Figure 1
Site Boundary Map

On-site improvements of the property include an approximately 13,500 square-foot vacant commercial building that formerly supported an Elks Lodge fraternity clubhouse. The three story building is composed of concrete block units (CMU) on a concrete slab. The remaining portion of the site is landscaped grass adjacent roadways and parking lots, as generally depicted in **Figure 1**.

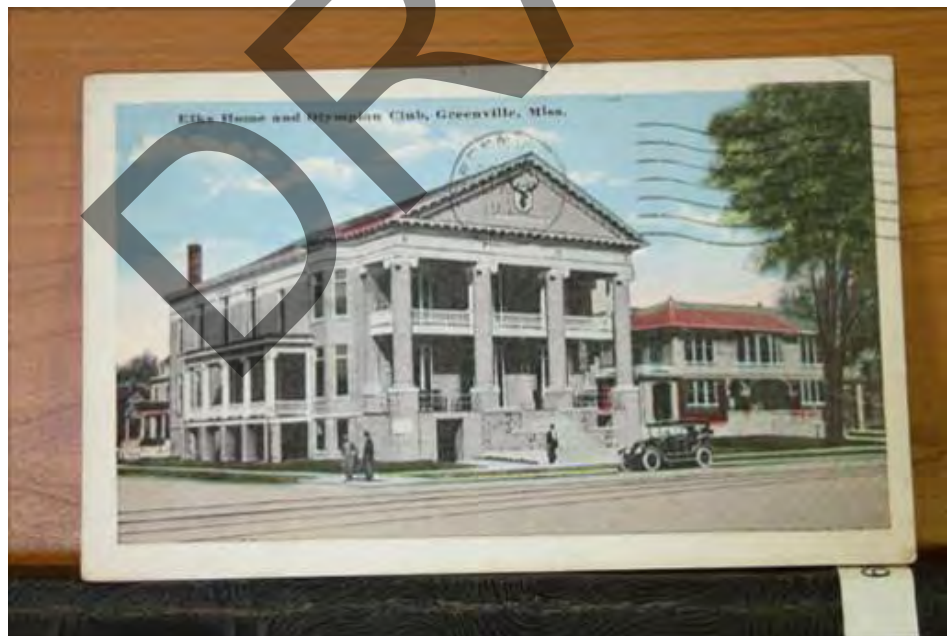
Figure 1: Postcard image from MDAH.

“In its heyday, the Benevolent and Protective Order of the Elk, No. 148 Lodge, also known as the “Cotton Pickers” Elk Lodge, was the social center for Greenville. Originally chartered in 1890, the “Cotton Pickers” built their once proud Neo-classic home in Greenville in 1906 and opened the doors in 1907. *The Greenville Times* of February 16, 1907, described the building as including a billiard hall, a barber shop, and a full library decorated with rare and expensive oil paintings and as being lighted by both gas and electricity. The “Cotton Pickers” Lodge has been converted many times since the Elks left. Now the home of the Mississippi Action for Community Education (M.A.C.E.), an organization committed to the preservation and education of African-American culture, the building is in urgent need of help. In the 1990’s, M.A.C.E. and other concerned citizens saved the building several times from the bulldozer and had the building designated a Mississippi Landmark in 2002. If care is not taken soon to restore the building, the city could force demolition.”

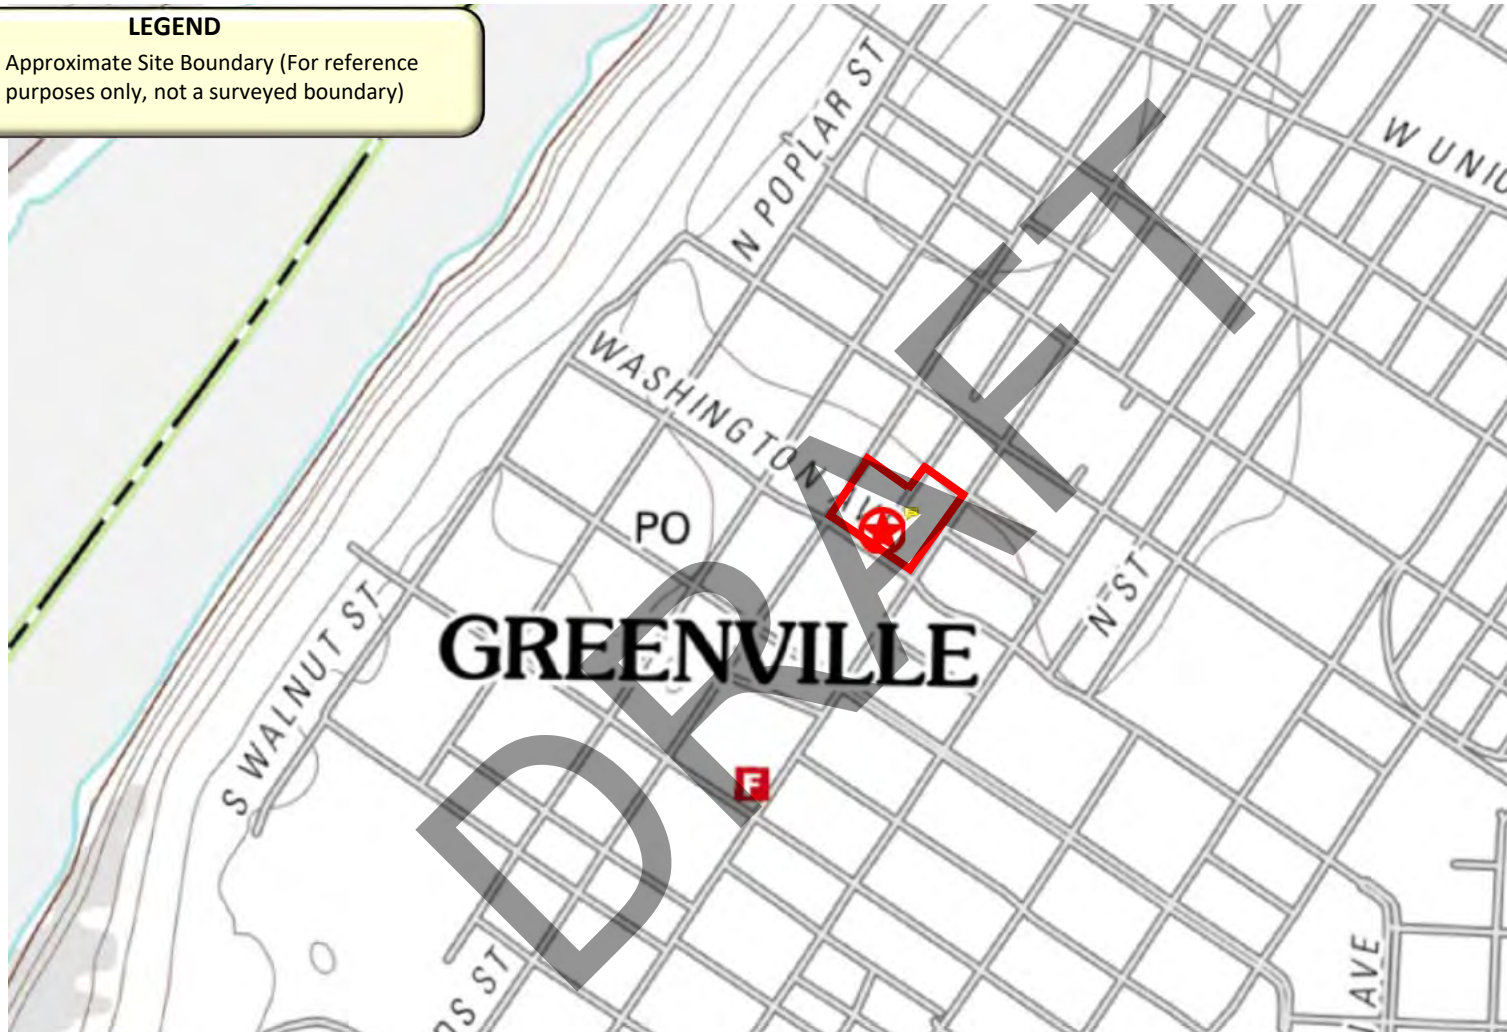
Figure 1
USGS/Site Vicinity Map
Source: USGS 2012

The 2012 USGS 7.5-minute series topographic map of Greenville, Mississippi quadrangle shows the property is relatively flat, with slight slopes to the east towards the adjacent canal, with the central portion of the site flat. Likely the central portion of the site was graded during the construction of the existing building. Topography ranges from approximately 125 to 135 feet above mean sea level (MSL). Based on map topography contours, the inferred primary direction of groundwater flow for the vicinity of the subject site is determined to be generally northwest towards the nearby Mississippi River. A USGS Topographic Map is included in **Figure 1**.
